## A water droplet erosion-induced fatigue crack propagation and failure in X20Cr13 martensitic stainless-steel turbines working at low pressure

<b>Manuscript Number:</b>	EFA-D-22-00546R2
<b>Article Type:</b>	Research Paper
<b>Keywords:</b>	erosion-fatigue, failure analysis, turbine, x20cr13 martensitic stainless steel, water droplet erosion
<b>Corresponding Author:</b>	SASIKUMAR CHANDRABALAN, Ph.D. Maulana Azad National Institute of Technology Bhopal, Madhya Pradesh INDIA
<b>First Author:</b>	Sarim Khan Mohd, M.Tech.
<b>Order of Authors:</b>	Sarim Khan Mohd, M.Tech. SASIKUMAR CHANDRABALAN, Ph.D.
<b>Abstract:</b>	<p>A low-pressure steam turbine blade failed at a thermal power plant reported in this paper. Few blades were damaged on the exhaust side, and the cracks originated on the trailing edge and spread toward the leading edge of blade. In the crack initiation point, shallow corrosion pits were evident, however, turbine vibrations were found to be actuating crack initiation and propagation. Due to numerous pits observed on blades surface, there were vibrations. A pressure drop on the exhaust side of the steam turbine caused condensation and water droplets impinging on the blade

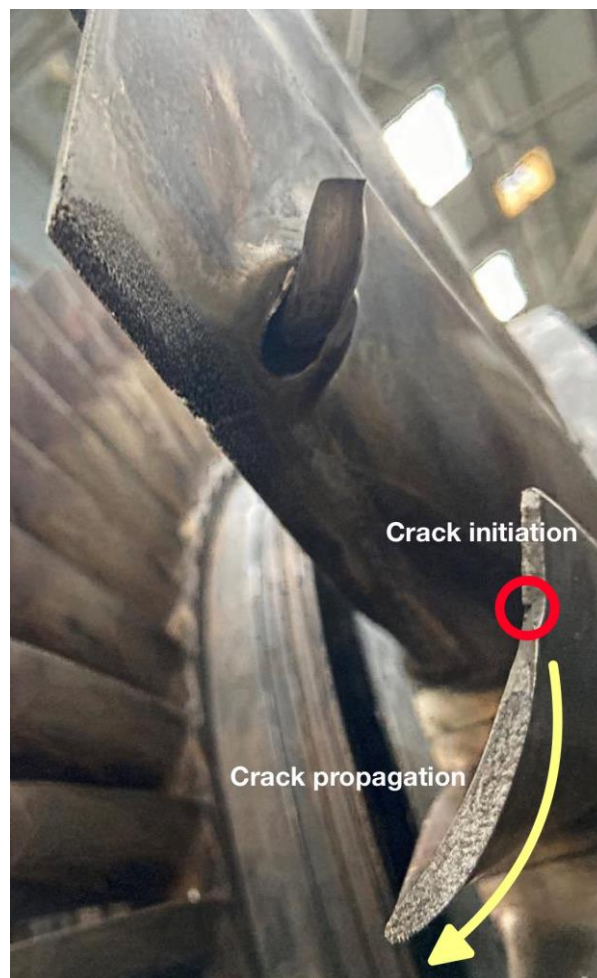
**Fig. 1.** In the photograph, a fracture is visible about 100 mm from the root of the turbine blade on the exhaust side of the steam turbine.

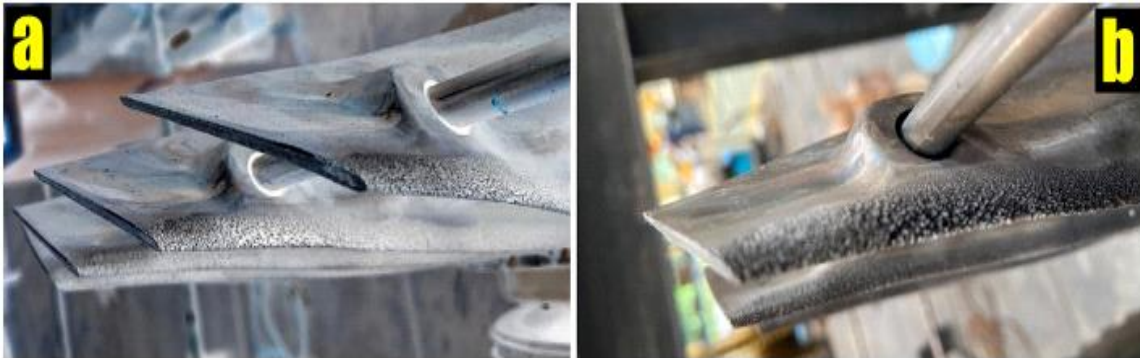
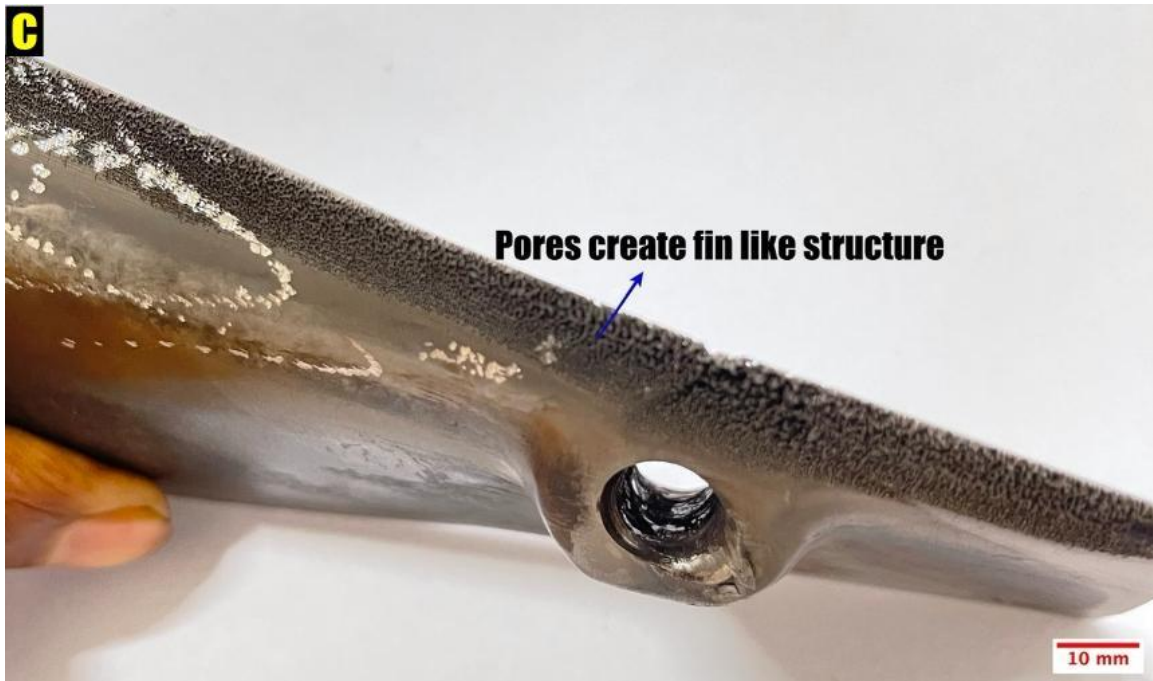
**Fig. 2(a, b, c).** The leading edges of turbine blades located on the exhaust side show several pits/grooves, an apparent fin-like texture.

Turbine blades on the exhaust side of a steam turbine are carefully inspected to discover damage at their surfaces. Figures 2a-c show typical images with fine pores along the leading edge of the blade on the convex side. A close inspection of these surfaces (figure 2c) revealed material was removed at these pores due to erosion/corrosion, resulting in fin-like structures. The fracture surfaces are depicted in Figure 3 a-c at concave and convex sides, as well as in a cross section. The fracture surface (3c) shows brittle and ductile fracture zones as well as beach marks in the crack propagation region that reveal fatigue mode fracture. Beach markings revealed the direction of the cracks and the crack initiation point. In addition, ratchet marks are visible at the fatigue crack regions, suggesting severe stress concentrations there. It is also noted that cracks are originating from different locations and that crack directions change along its path, indicating a torsional load is present at this point.

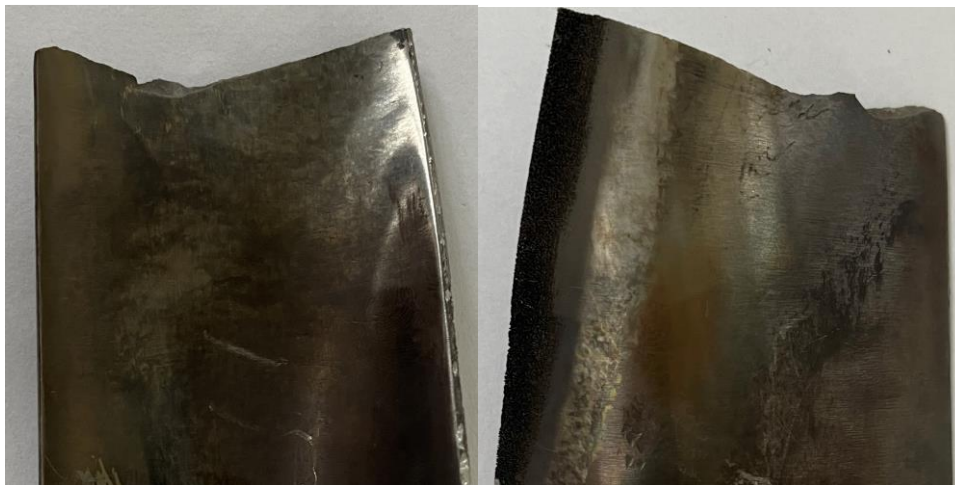
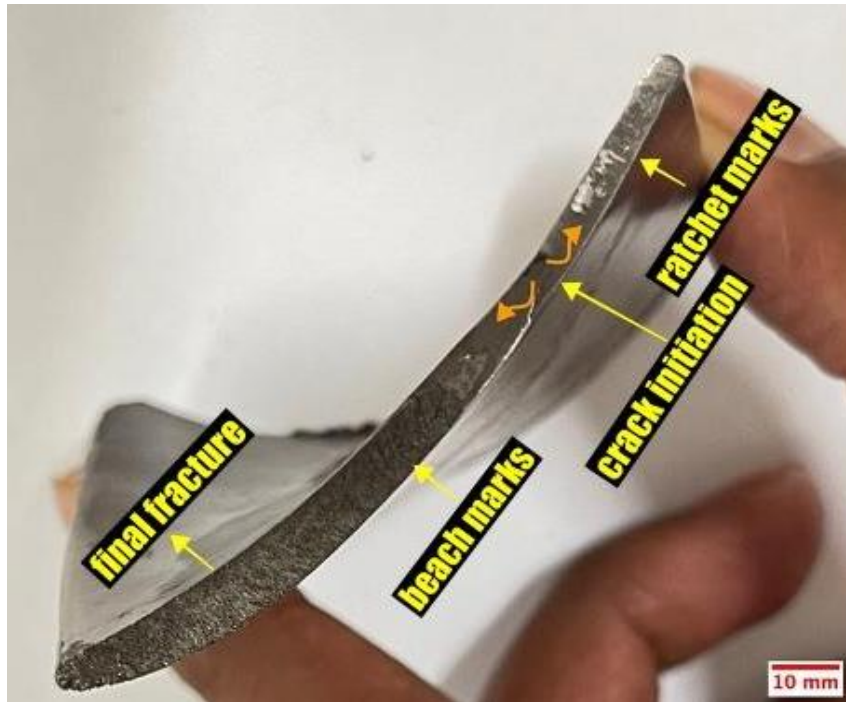
**Fig. 3.** Fracture surfaces shown in (a) concave and (b) convex perspectives, and (c) cross sections demonstrating crack initiation point, crack propagation region with beach marks and the final fast fracture region.

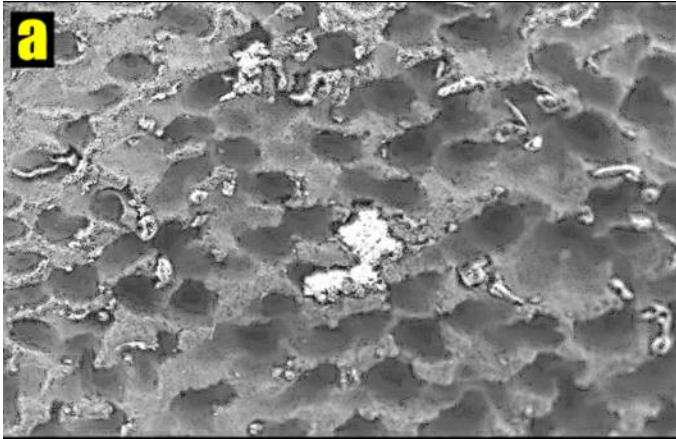
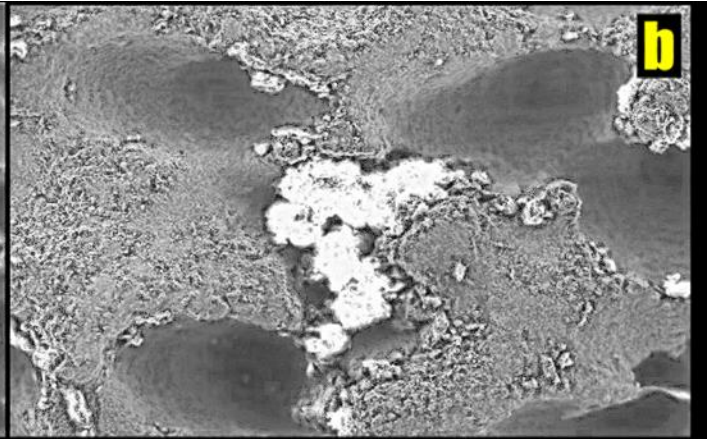
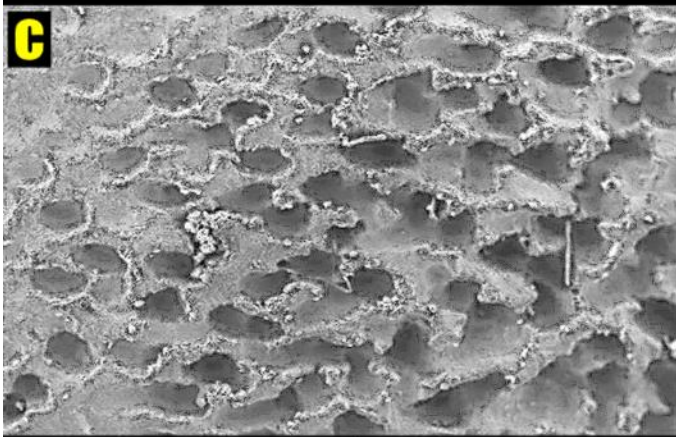
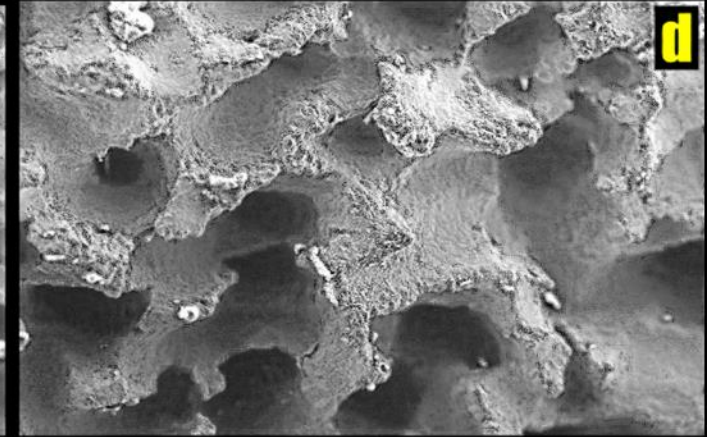
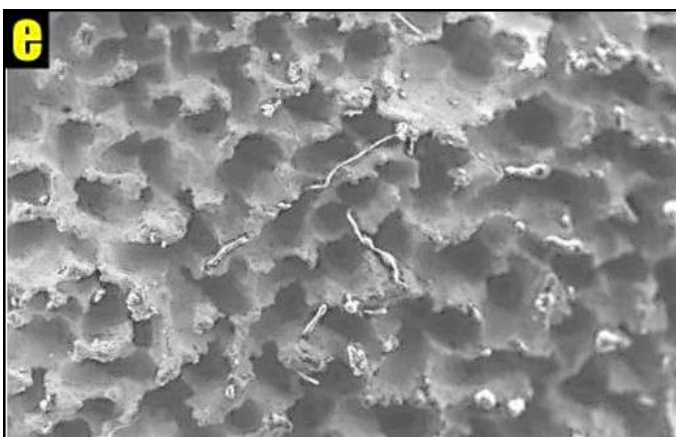
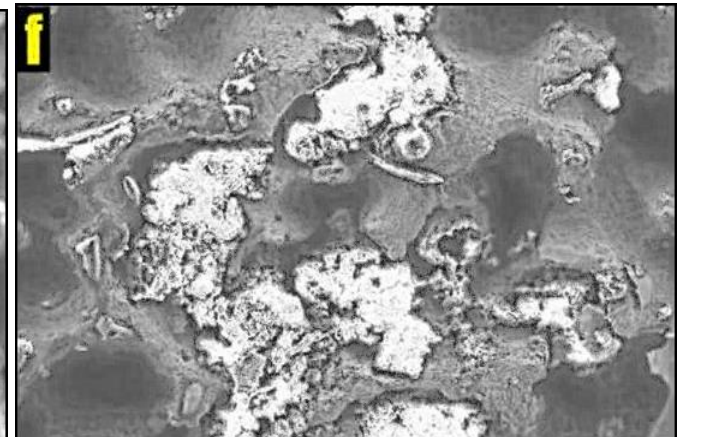
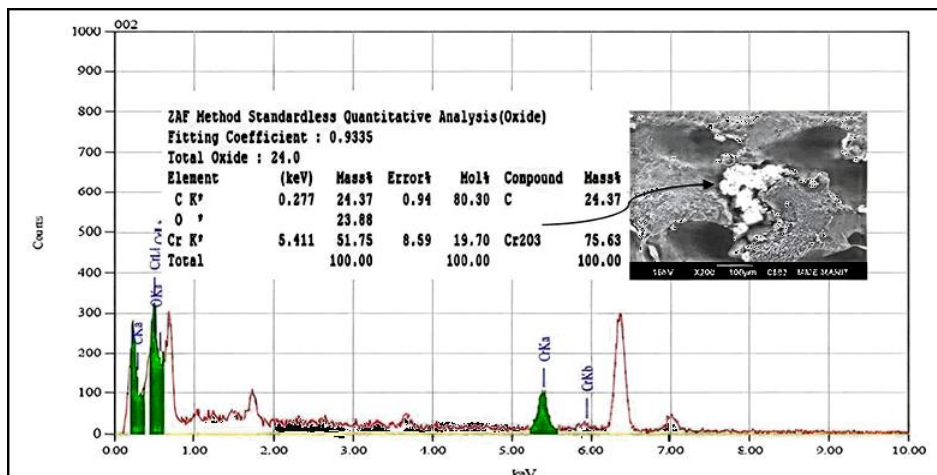
The low magnification image of the fractured surface of the failed blade at the trailing edge is shown in Figure 4 a-f. There are several pits uniformly distributed on the leading edges, each with a diameter of about 100 micrometers. An examination of these sites close up revealed that bright phases had been eroded away, resulting in the formation of deep pores. EDX analysis of these eroding phases shows Cr, O, and carbon peaks (fig.4g).

**Fig. 4 (a-f).** SEM images on the leading edges show uniformly distributed pores, and they are deeply penetrating, with an average diameter of 100m. (g) EDX data on the phases eroded away from the leading edges indicates carbon, Cr and oxygen peaks.

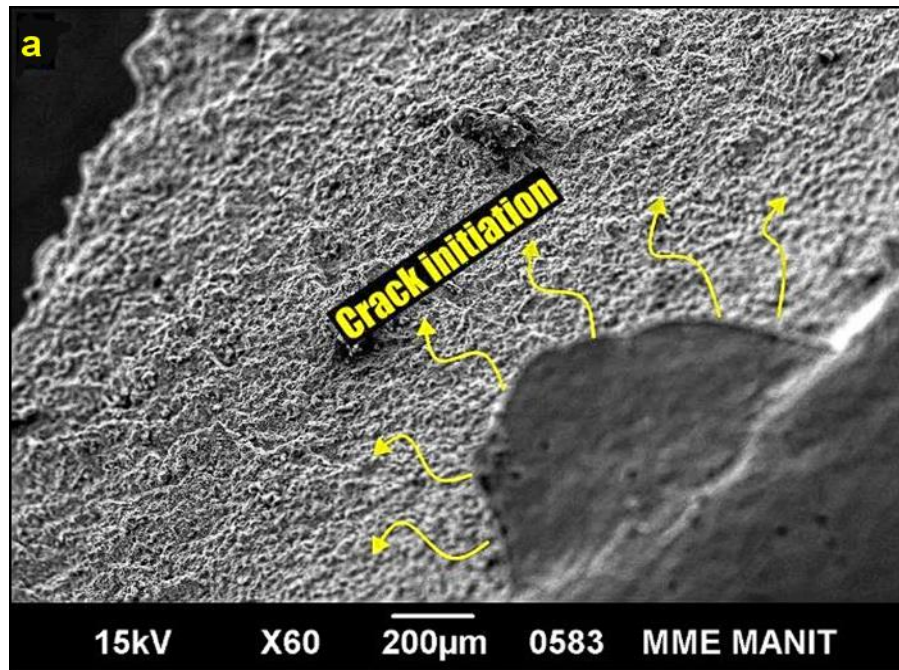
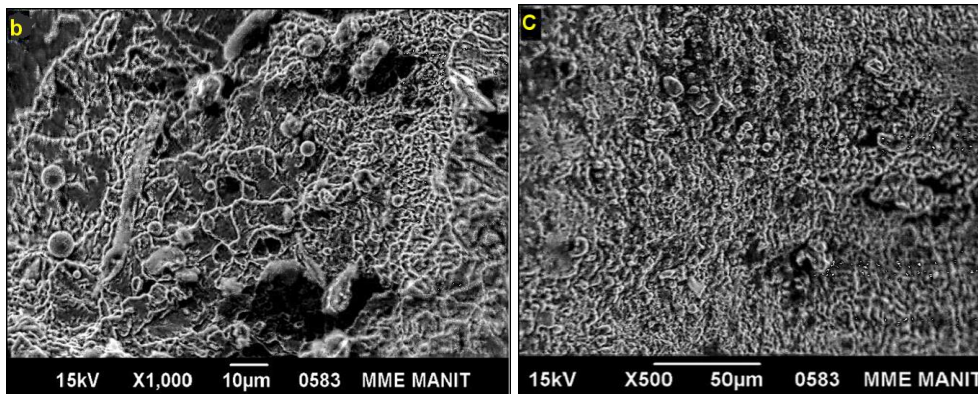
**Fig. 5 .** (a) Crack originating at the trailing edge of the turbine blade from a shallow pit/pore. Beach marks and ratchet marks are also visible in areas of crack propagation. (b) As the crack propagates, it reveals a smooth surface, indicating an intergranular fracture mode in the zone nearer the crack initiation. (c) Final fast fracture region

In figure 5(a), the crack found originates from the trailing edge of the turbine blade, even though the leading edge has several deep pores. A crack that originates from a shallow pit/pore

located near the trailing edge of the turbine blade. In crack propagation regions, beach marks as well as ratchet marks can be observed. The ratchet marks in different directions indicate how the direction of the crack changes as the turbine blade rotates.

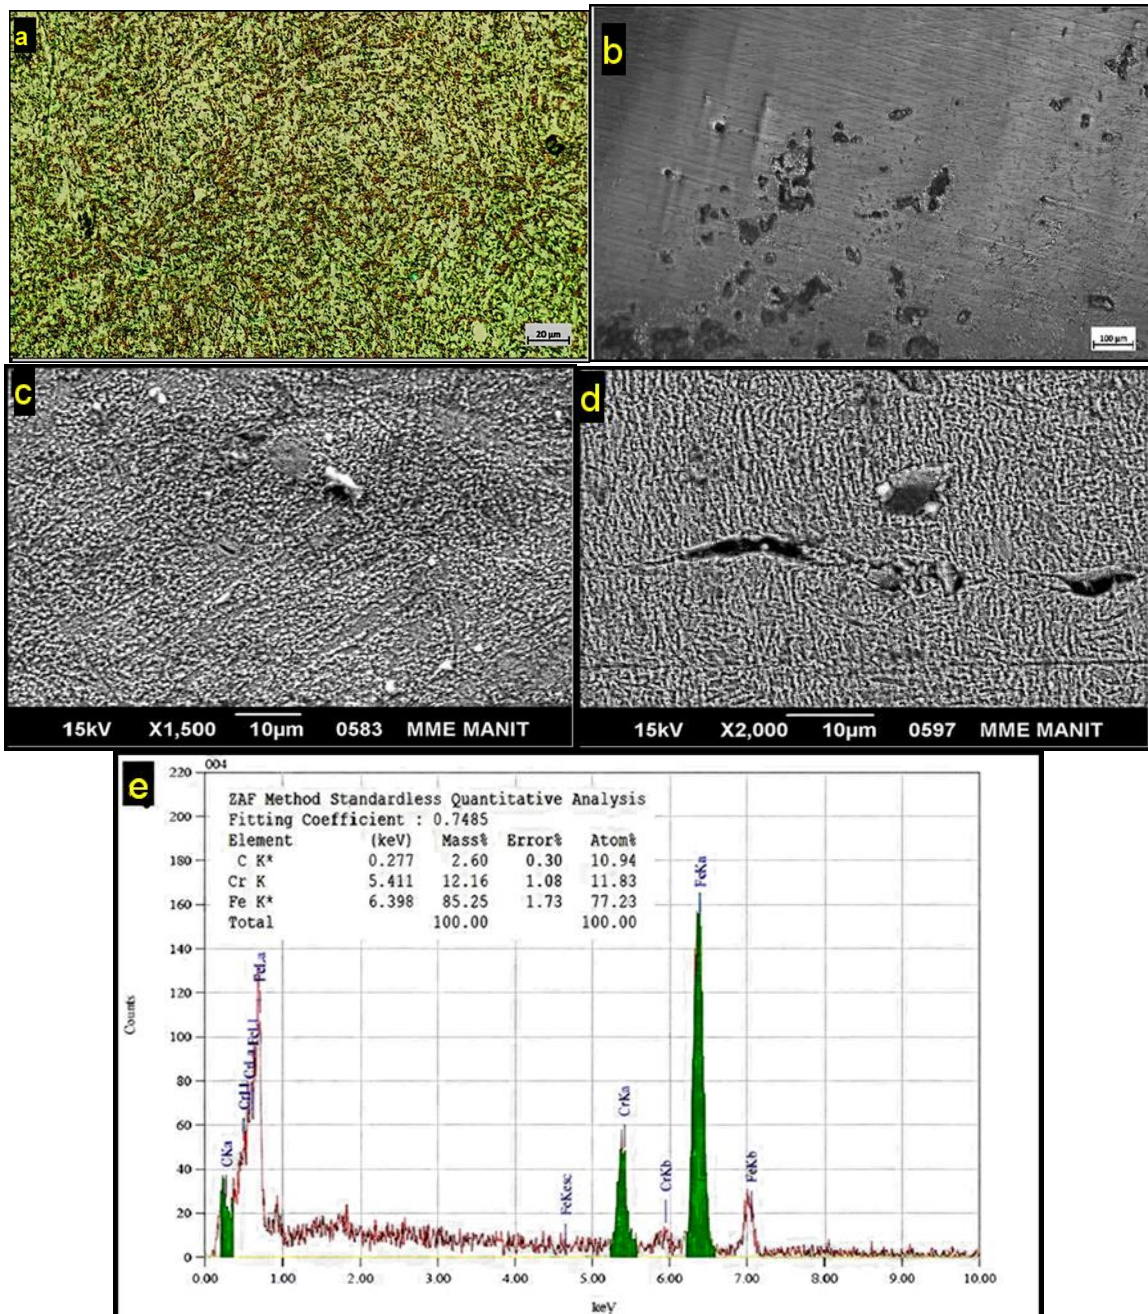
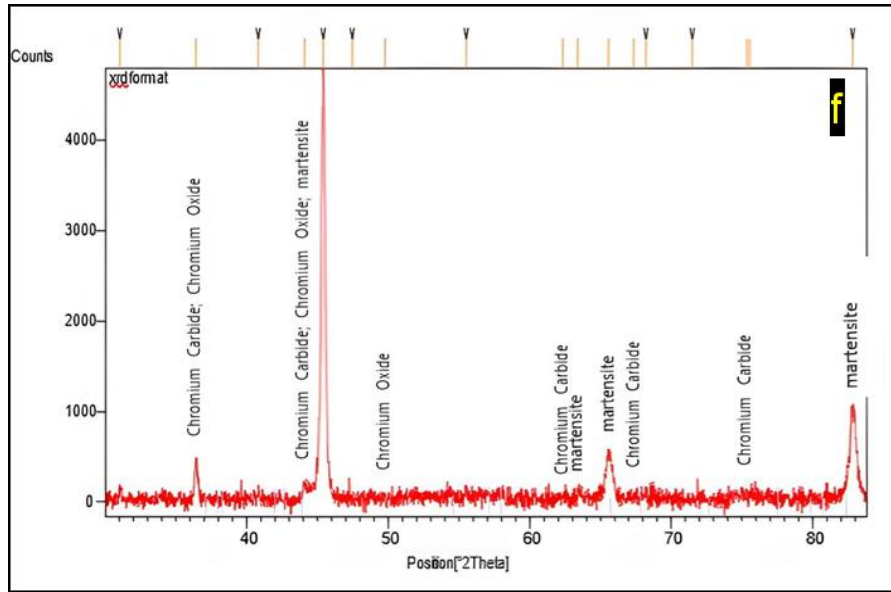
**Fig. 6.** (a) The optical microscope reveals carbide precipitates on the turbine blade's surface (b) An inclusion rating showed oxide inclusions near the leading edges where pores form (c) SEM microstructure reveals uniform precipitates of chromium carbide within the lath martensitic matrix (d) EDX spectrum on the precipitates (bright spots) indicates chromium and carbon peaks indicating chromium carbide. (e) XRD analysis at the surface near to porous region.

As can be seen in figure 6 a and b, the optical microscopy images show the surface microstructure and inclusions near the porous region of the turbine blade. The surface microstructure revealed uniformly distributed carbides in the matrix phase. The presence of oxide inclusions is significantly increased at the failed region. A rating of the sample's inclusion is performed at different parts of the sample, and the typical results are shown in Table 2.

The SEM microstructure reveals lath martensite and chromium carbide precipitates uniformly distributed within it (fig. 6c). Microcracks can be seen at a few locations on the concave side of the turbine blade (fig. 6d). The EDX spot analysis shows chromium and carbon peaks in addition to iron peaks, indicating that the precipitates are chromium carbide. The xrd results obtained at the region of failed surface is shown in figure 6f. The analysis revealed martensite as a predominant phase in the steel and also confirmed the presence of chromium carbide and chromium oxide.

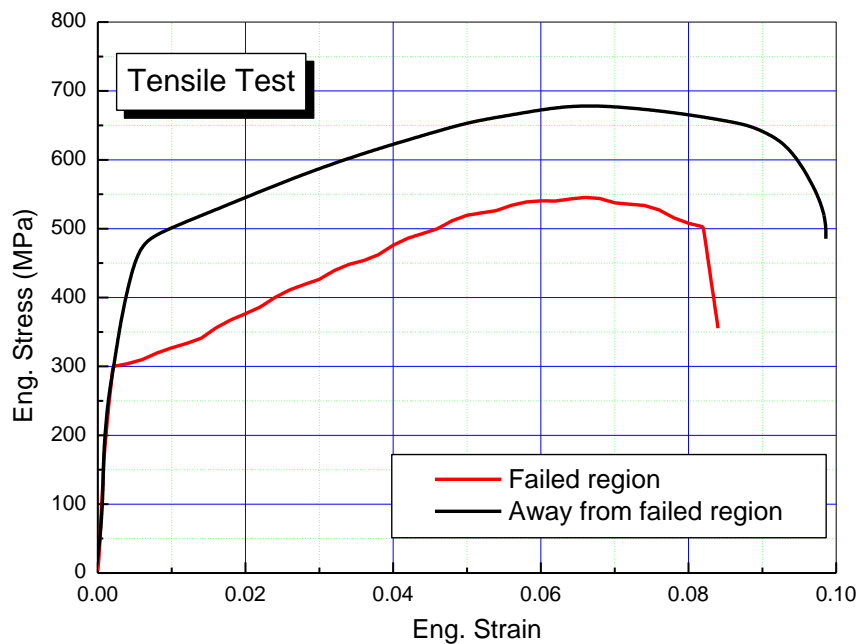
**Fig. 7.** Tensile test results of the turbine blades in the unfailed region and in the exhaust region where it failed.

The tensile test revealed a yield strength of 500 MPa and a tensile strength of 690 MPa in the unfailed region and a yield strength of 310 MPa and a tensile strength of 550 MPa in the

failed region. The ductility also reduced in the failed region. In response to hydrogenating conditions, metallic components are susceptible to hydrogen embrittlement, which results in severe mechanical degradation [14-18]. Hydrogen embrittlement exhibits a prominent loss of strength, ductility, fracture toughness, and fatigue durability as reported elsewhere [19-23],

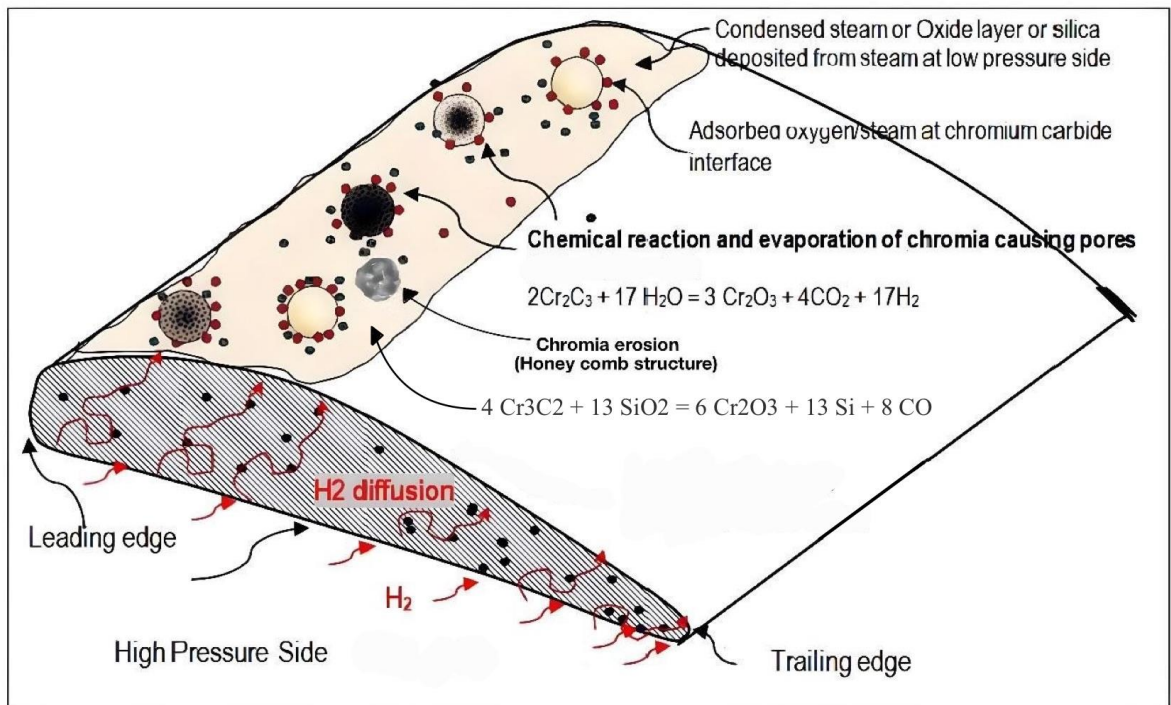
As discussed above, chromium carbides react chemically with steam, resulting in chromia formation and subsequent evaporation at low pressure side of turbine blades [8], creating circular pores. The pore formation mechanism can be visualized in Figure 8.

**Fig. 8.** Visualization of pore formation mechanism in turbine blade under investigation.

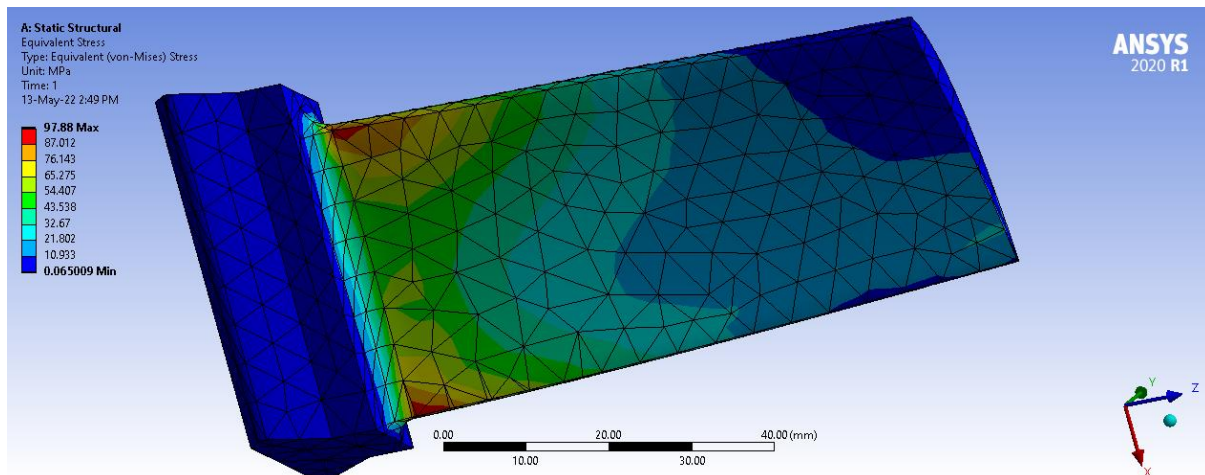
Fig.9. Equivalent Von-Mises stress

Figure 9 shows peak stress 97.88 Mpa, and Avg. stress of 15 Mpa was observed. However, the presence of pores/grooves causes crack initiation [29,30,32.33].

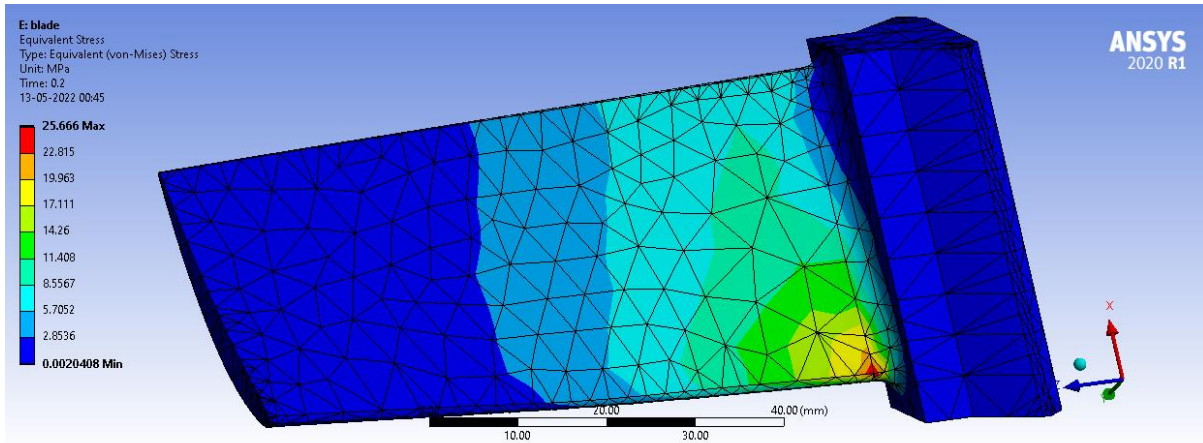
Fig.10. Equivalent Von-Mises stress after pore introduction of 0.1mm

Figure 10 shows that the crack would begin at 25.66 MPa if the material has pore/grooves of 0.1 mm. As the turbine blades are experiencing a stress of about 97.88 MPa, cracks are propagating from the pores on the high-pressure side. Thus, the pores and microcracks at the concave surfaces had made the blades vulnerable for crack initiation and fatigue failure. Few other studies also showed similar reports [30,31,35].
