## A water droplet erosion-induced fatigue crack propagation and failure in X20Cr13 martensitic stainless-steel turbines working at low pressure

<b>Manuscript Number:</b>	EFA-D-22-00546R2
<b>Article Type:</b>	Research Paper
<b>Keywords:</b>	erosion-fatigue, failure analysis, turbine, x20cr13 martensitic stainless steel, water droplet erosion
<b>Corresponding Author:</b>	SASIKUMAR CHANDRABALAN, Ph.D. Maulana Azad National Institute of Technology Bhopal, Madhya Pradesh INDIA
<b>First Author:</b>	Sarim Khan Mohd, M.Tech.
<b>Order of Authors:</b>	Sarim Khan Mohd, M.Tech. SASIKUMAR CHANDRABALAN, Ph.D.
<b>Abstract:</b>	<p>A low-pressure steam turbine blade failed at a thermal power plant reported in this paper. Few blades were damaged on the exhaust side, and the cracks originated on the trailing edge and spread toward the leading edge of blade. In the crack initiation point, shallow corrosion pits were evident, however, turbine vibrations were found to be actuating crack initiation and propagation. Due to numerous pits observed on blades surface, there were vibrations. A pressure drop on the exhaust side of the steam turbine caused condensation and water droplets impinging on the blade

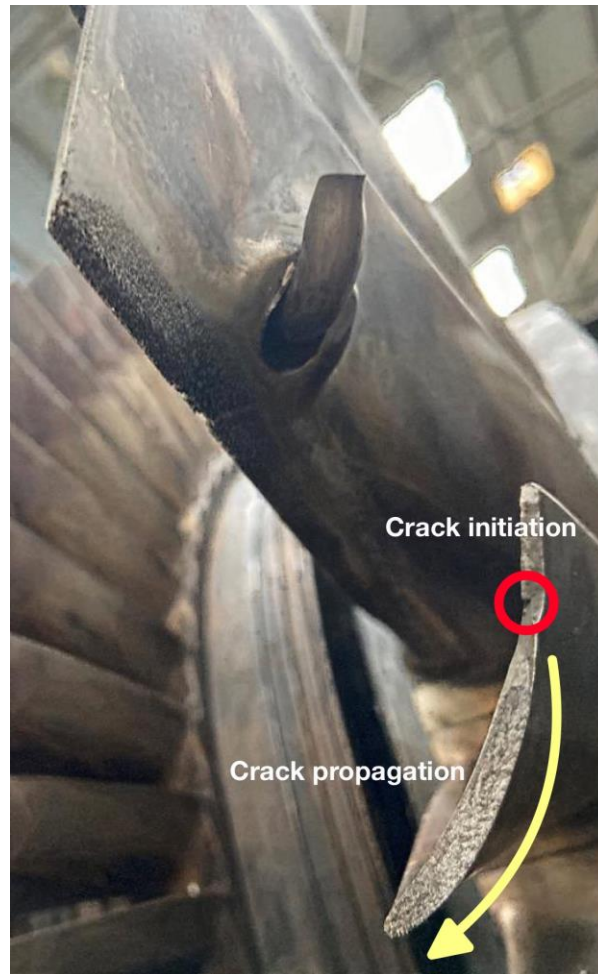
**Fig. 1.** In the photograph, a fracture is visible about 100 mm from the root of the turbine blade on the exhaust side of the stream turbine.

**Fig. 1.** In the photograph, a fracture is visible about 100 mm from the root of the turbine blade on the exhaust side of the steam turbine.

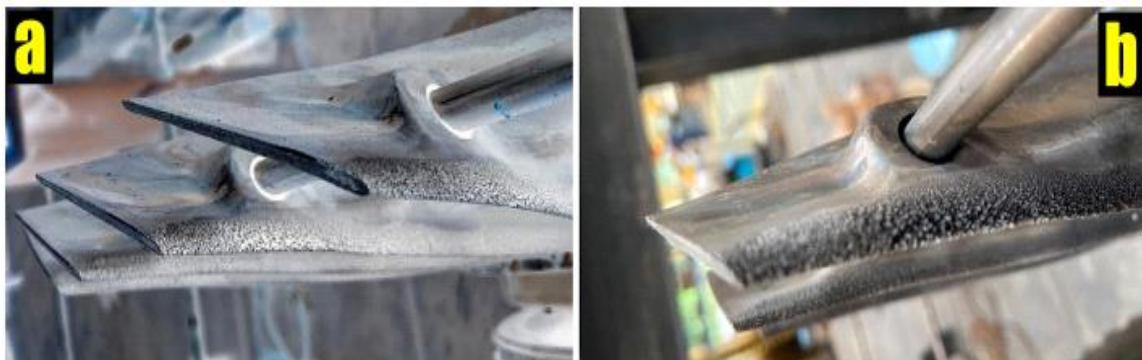
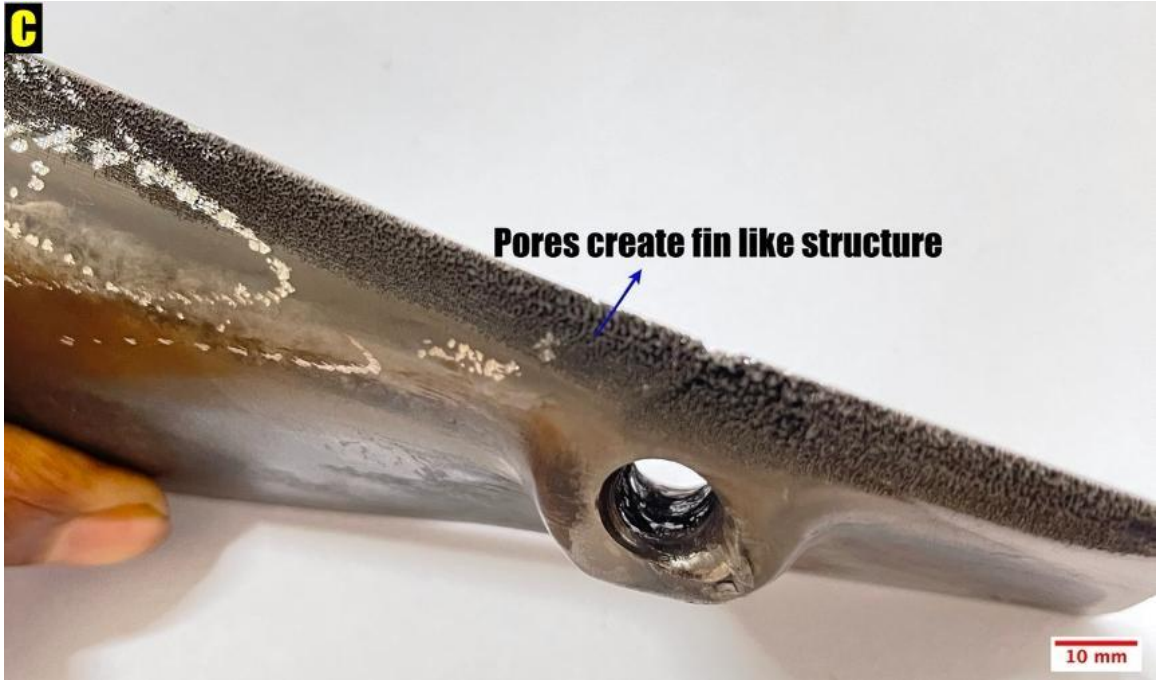
**Fig. 2(a, b, c).** The leading edges of turbine blades located on the exhaust side show several pits/grooves, an apparent fin-like texture.

Turbine blades on the exhaust side of a steam turbine are carefully inspected to discover damage at their surfaces. Figures 2a-c show typical images with fine pores along the leading edge of the blade on the convex side. A close inspection of these surfaces (figure 2c) revealed material was removed at these pores due to erosion/corrosion, resulting in fin-like structures. The fracture surfaces are depicted in Figure 3 a-c at concave and convex sides, as well as in a cross section. The fracture surface (3c) shows brittle and ductile fracture zones as well as beach marks in the crack propagation region that reveal fatigue mode fracture. Beach markings revealed the direction of the cracks and the crack initiation point. In addition, ratchet marks are visible at the fatigue crack regions, suggesting severe stress concentrations there. It is also noted that cracks are originating from different locations and that crack directions change along its path, indicating a torsional load is present at this point.

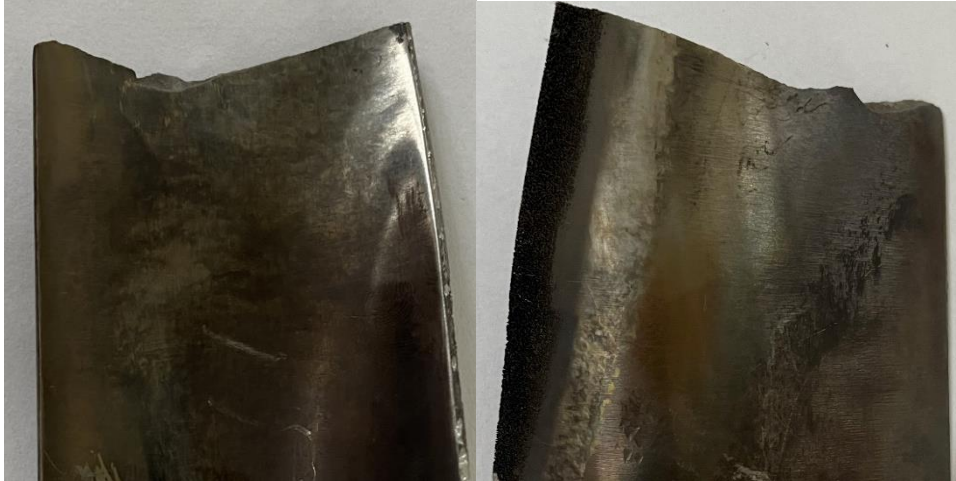
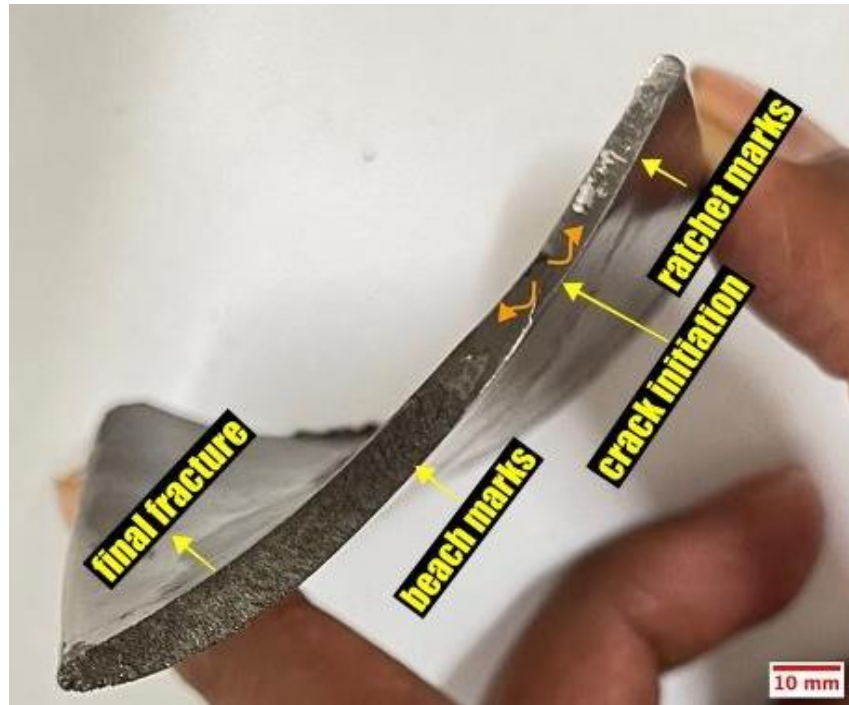
**Fig. 3.** Fracture surfaces shown in (a) concave and (b) convex perspectives, and (c) cross sections demonstrating crack initiation point, crack propagation region with beach marks and the final fast fracture region.

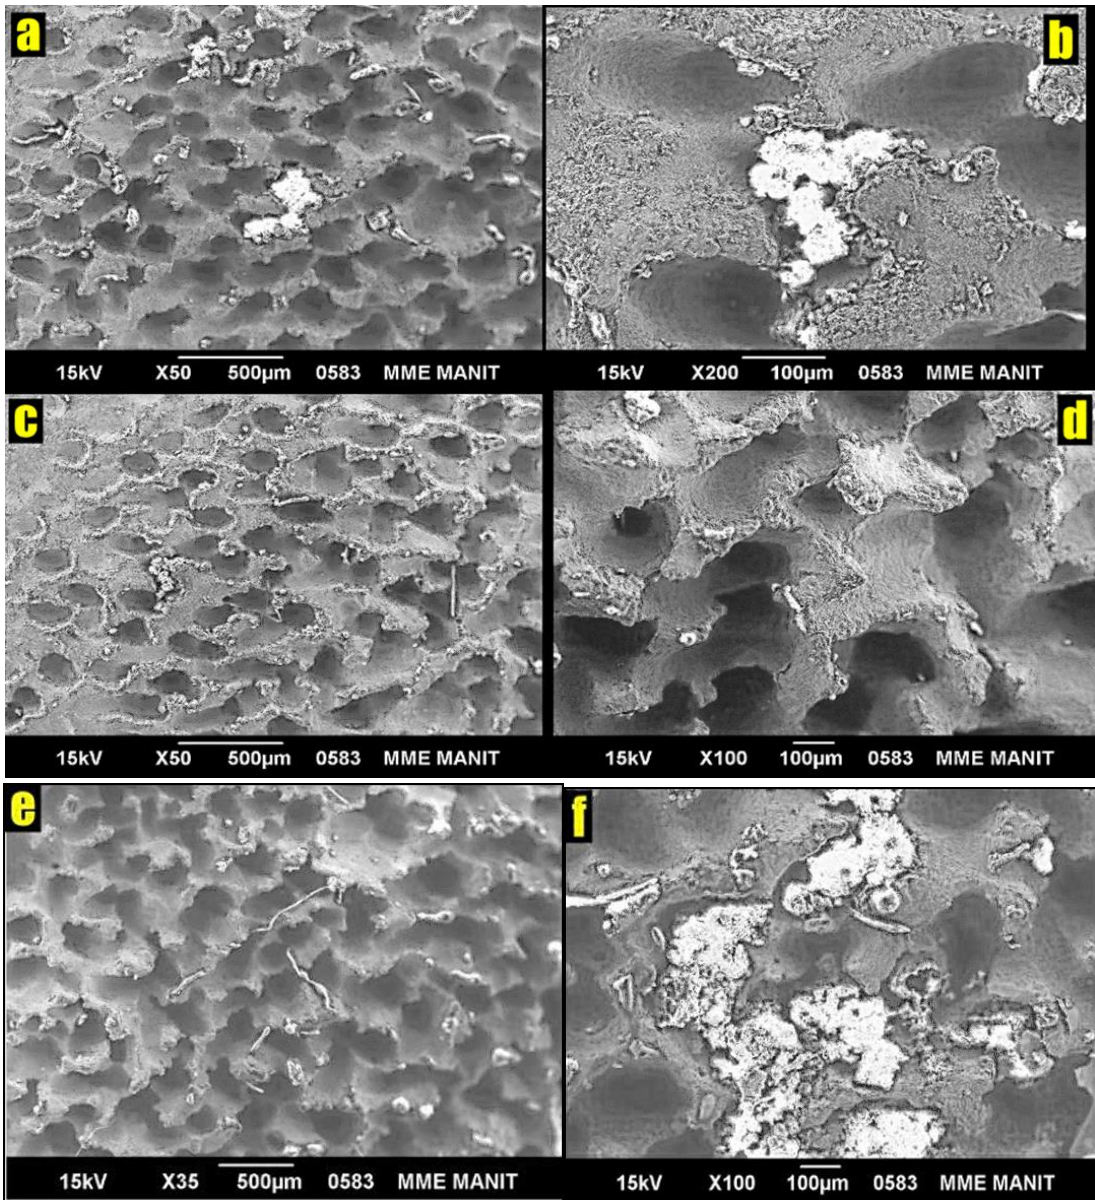
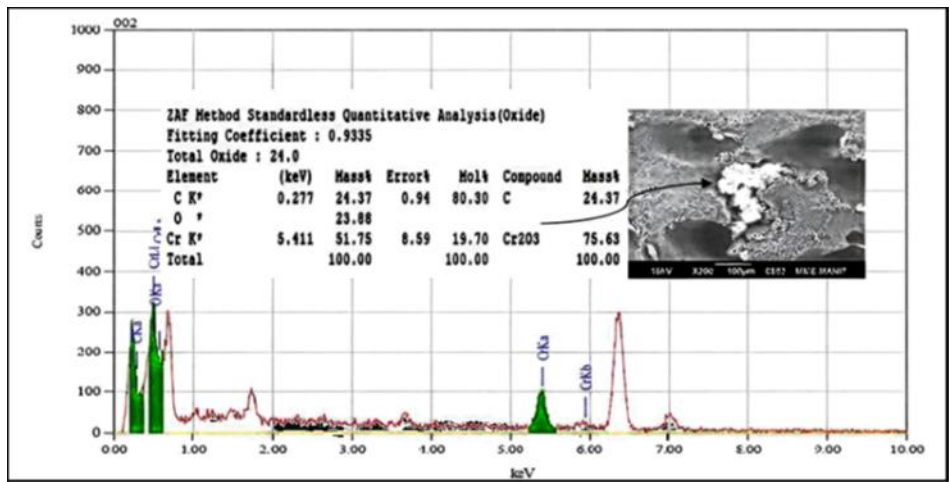
**Fig. 4 (a-f).** SEM images on the leading edges show uniformly distributed pores, and they are deeply penetrating, with an average diameter of 100m. (g) EDX data on the phases eroded away from the leading edges indicates carbon, Cr and oxygen peaks.

The low magnification image of the fractured surface of the failed blade at the trailing edge is shown in Figure 4 a-f. There are several pits uniformly distributed on the leading edges, each with a diameter of about 100 micrometers. An examination of these sites close up revealed that bright phases had been eroded away, resulting in the formation of deep pores. EDX analysis of these eroding phases shows Cr, O, and carbon peaks (fig.4g).

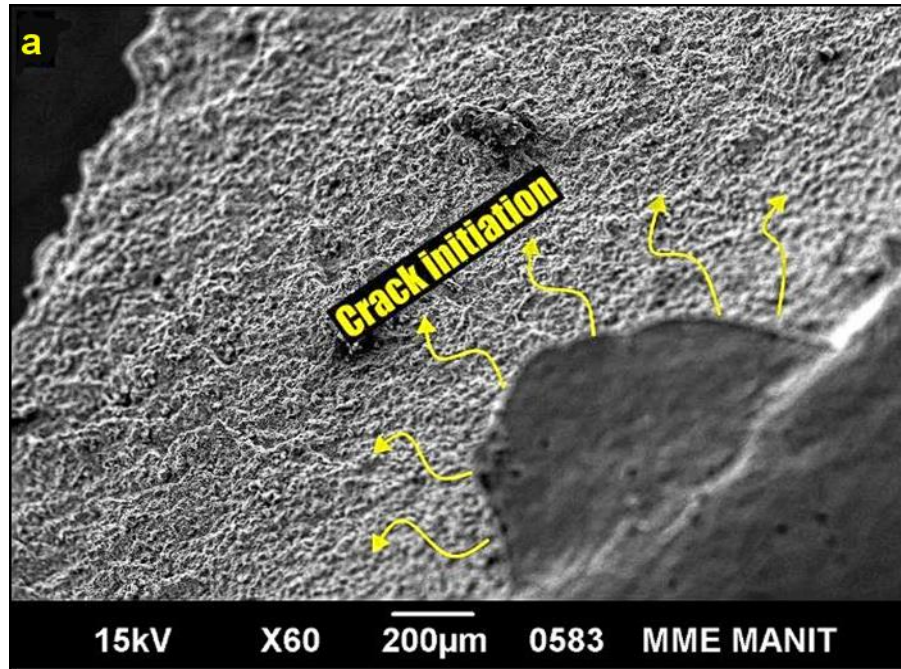
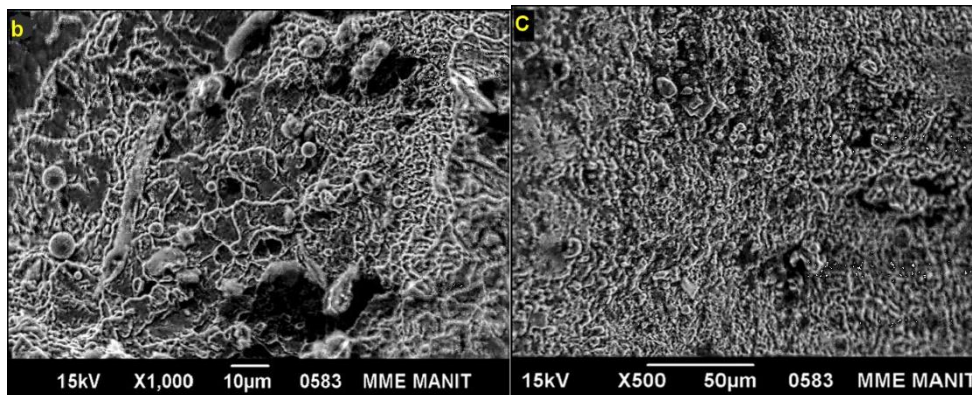
**Fig. 5 .** (a) Crack originating at the trailing edge of the turbine blade from a shallow pit/pore. Beach marks and ratchet marks are also visible in areas of crack propagation. (b) As the crack propagates, it reveals a smooth surface, indicating an intergranular fracture mode in the zone nearer the crack initiation. (c) Final fast fracture region

In figure 5(a), the crack found originates from the trailing edge of the turbine blade, even though the leading edge has several deep pores. A crack that originates from a shallow pit/pore

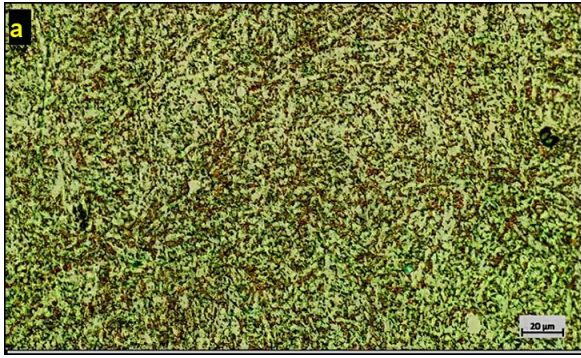
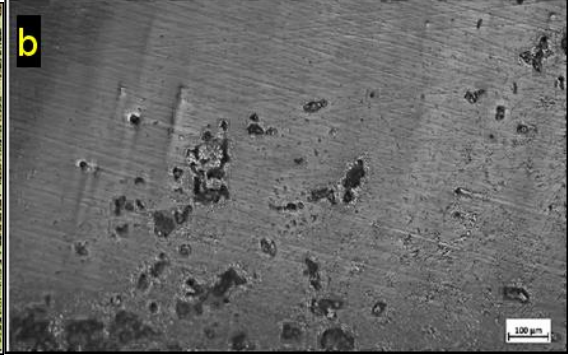
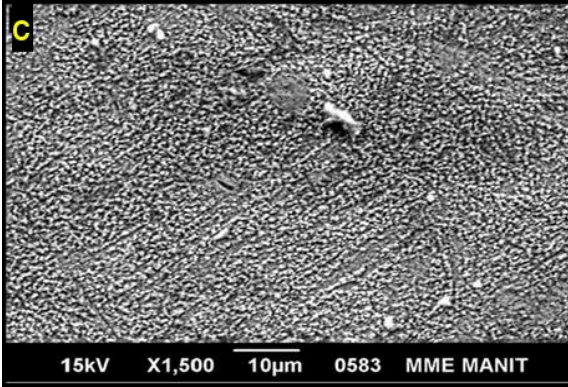
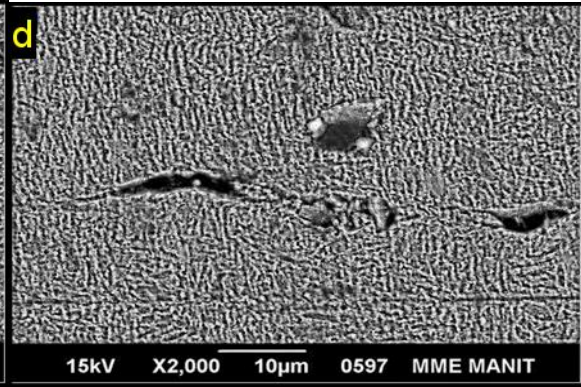
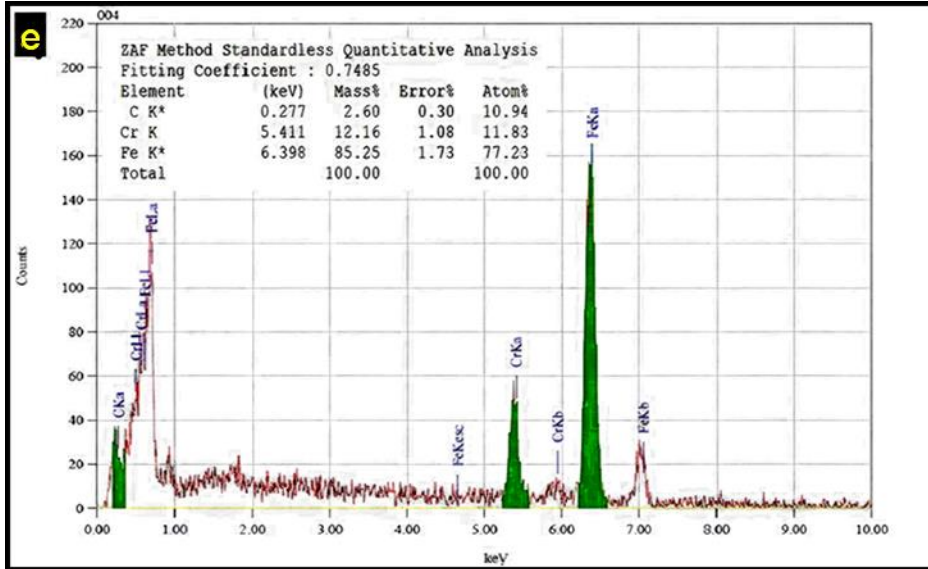
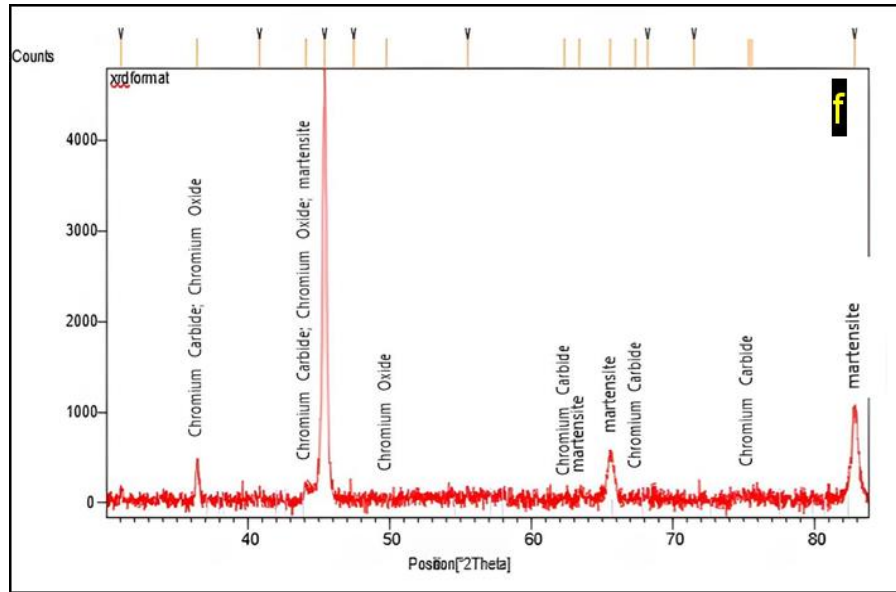
**Fig. 6.** (a) The optical microscope reveals carbide precipitates on the turbine blade's surface (b) An inclusion rating showed oxide inclusions near the leading edges where pores form (c) SEM microstructure reveals uniform precipitates of chromium carbide within the lath martensitic matrix (d) EDX spectrum on the precipitates (bright spots) indicates chromium and carbon peaks indicating chromium carbide. (e) XRD analysis at the surface near to porous region.

As can be seen in figure 6 a and b, the optical microscopy images show the surface microstructure and inclusions near the porous region of the turbine blade. The surface microstructure revealed uniformly distributed carbides in the matrix phase. The presence of oxide inclusions is significantly increased at the failed region. A rating of the sample's inclusion is performed at different parts of the sample, and the typical results are shown in Table 2.

The SEM microstructure reveals lath martensite and chromium carbide precipitates uniformly distributed within it (fig. 6c). Microcracks can be seen at a few locations on the concave side of the turbine blade (fig. 6d). The EDX spot analysis shows chromium and carbon peaks in addition to iron peaks, indicating that the precipitates are chromium carbide. The xrd results obtained at the region of failed surface is shown in figure 6f. The analysis revealed martensite as a predominant phase in the steel and also confirmed the presence of chromium carbide and chromium oxide.

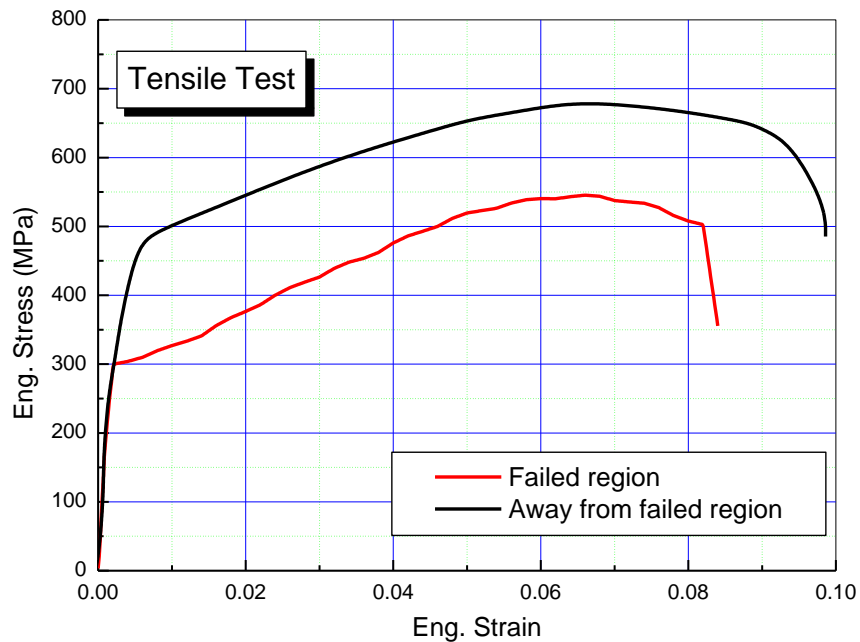
**Fig. 7.** Tensile test results of the turbine blades in the unfailed region and in the exhaust region where it failed.

The tensile test results of the samples in the failed and unfailed regions are shown in figure 7.

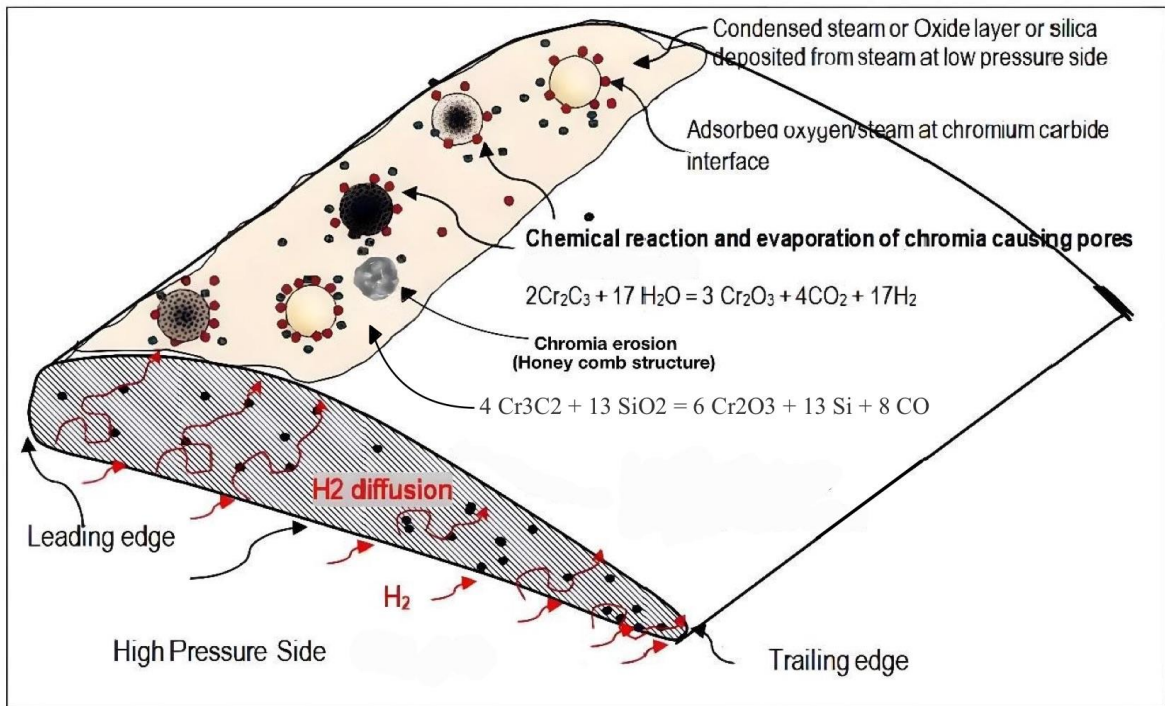
Fig. 8. Visualization of pore formation mechanism in turbine blade under investigation.

As discussed above, chromium carbides react chemically with steam, resulting in chromia formation and subsequent evaporation at low pressure side of turbine blades [8], creating circular pores. The pore formation mechanism can be visualized in Figure 8.

**Fig. 8.** Visualization of pore formation mechanism in turbine blade under investigation.

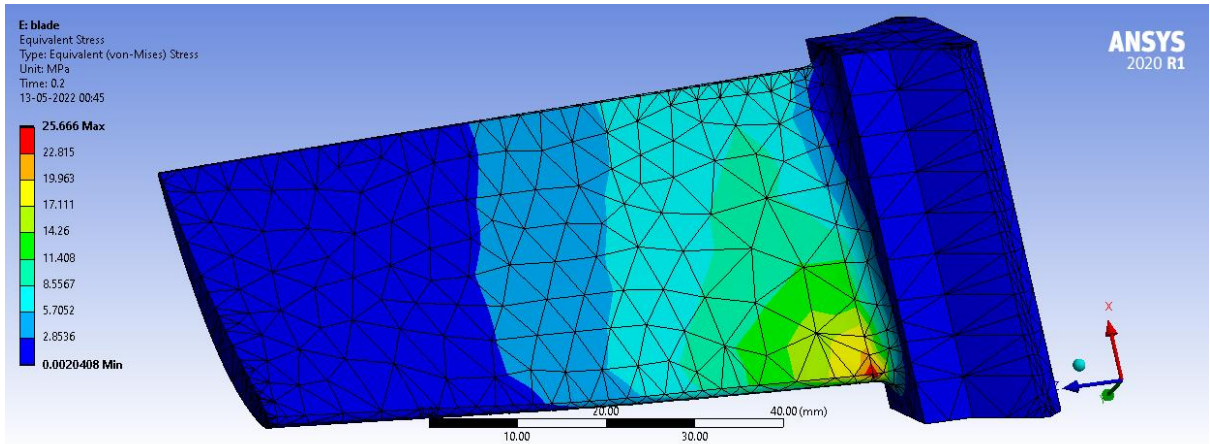
Fig.10. Equivalent Von-Mises stress after pore introduction of 0.1mm
